NBS BUILDING SCIENCE SERIES 94

Investigation of the Skelton House Collapse
in Fairfax County, Virginia

Investigation of the Skyline Plaza Collapse in Fairfax County, Virginia

NBS Building Research Institute, Inc. 34
Edgar V. Leyendecker and S. George Fattal

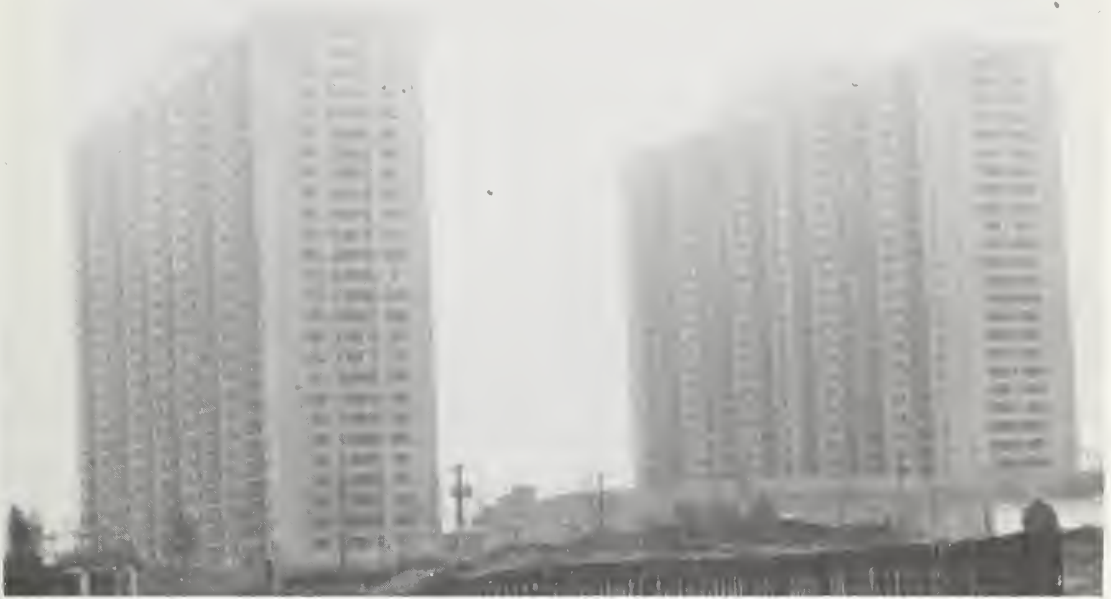
Figure 1.1 Appearance of completed apartment buildings.

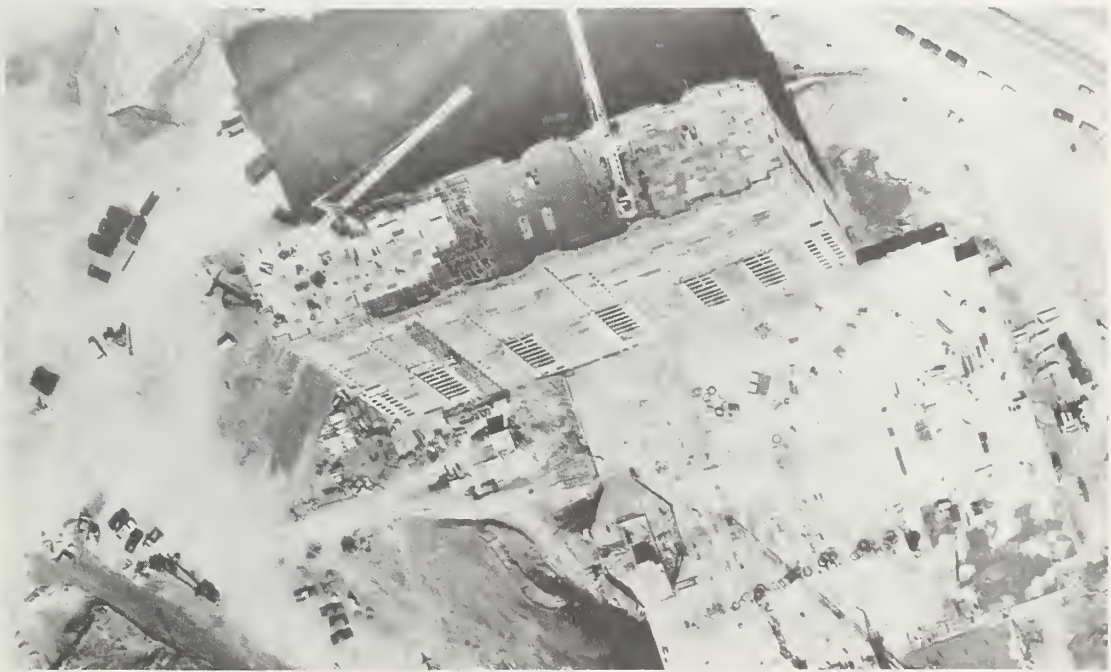
Figure 1.3 Appearance of the collapsed structures as viewed from the southeast.

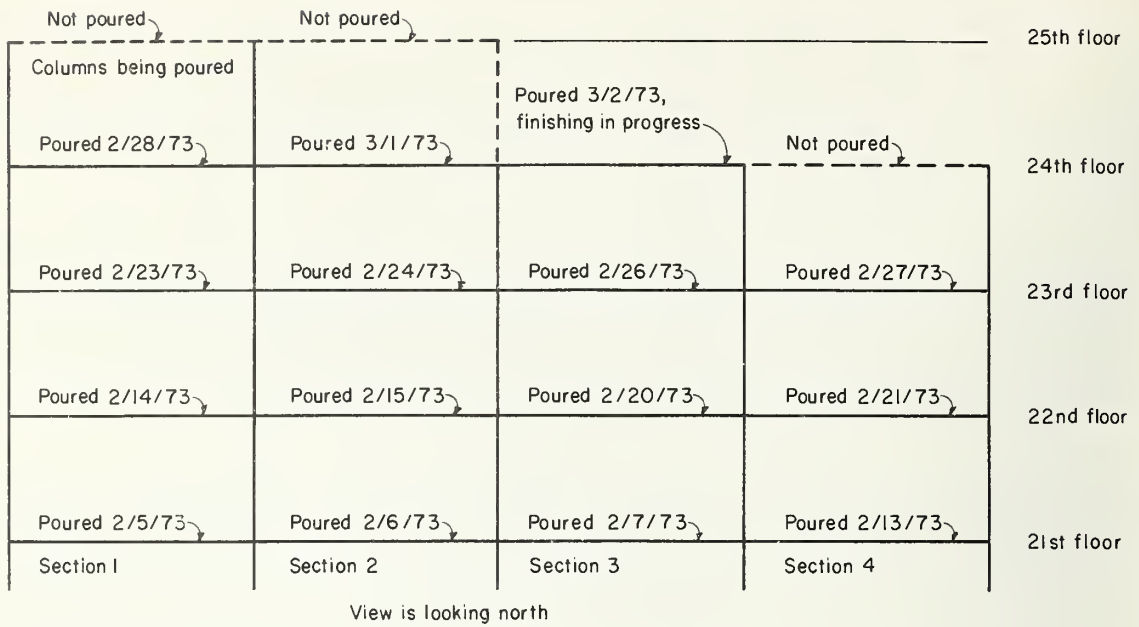
A typical floor of the building was poured in four sections; the progress of construction at the time of the collapse is shown in figure 2.2 [18]. The actual sizes of the pour sections are shown in figure 2.1. Note that the sections are not equal in size and configuration. According to statements provided to OSHA, a normal construction rate was one section a day. This rate of construction would permit the completion of one floor per week and allow an extra day for weather variation. In actual practice, this rate was not always maintained as indicated in figure 2.3.

Figure 2.2 Extent of construction at the time of collapse.

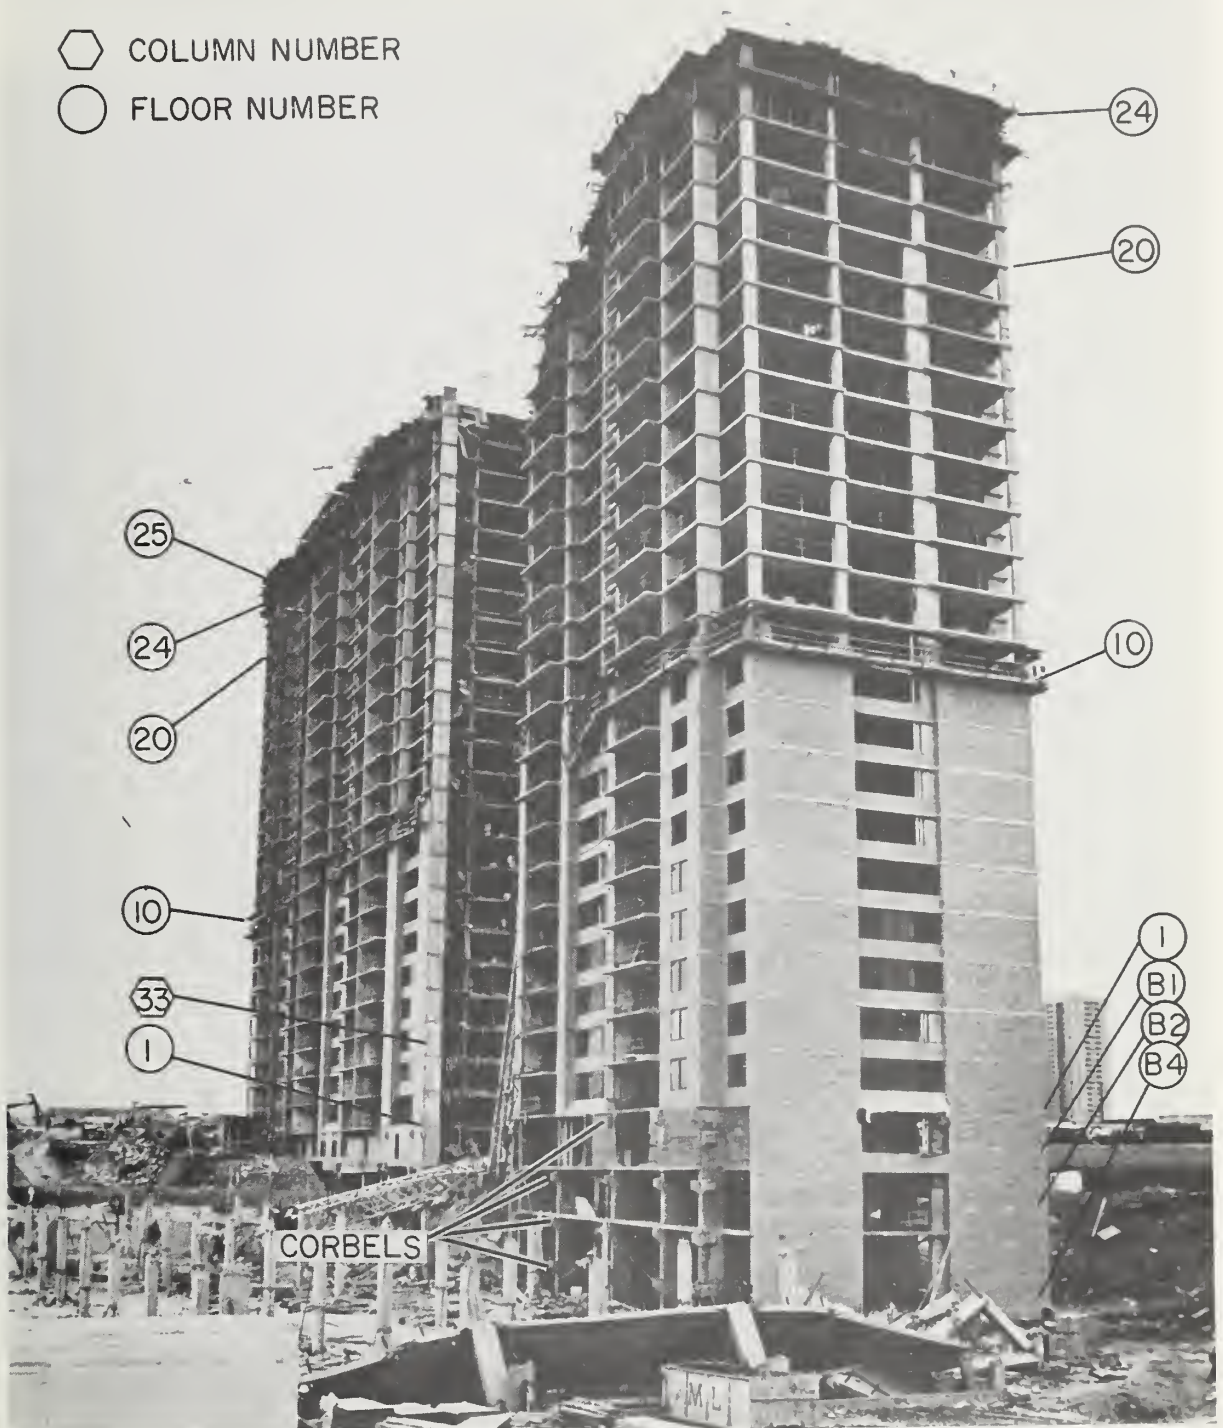
The general appearance of the building A-4 as viewed from the southeast after the collapse is shown in figure 2.4. A number of the floors and one of the columns is identified for later reference. Note the absence of a floor slab at level B-3 (in accordance with the plans). Note also the column corbels at floor levels B-3, B-2, B-1, and 1. These corbels supported one edge of the parking garage slabs. Level B-4 of the garage was on grade.

Figure 2.4 General appearance of building A-4 as viewed from the southeast.

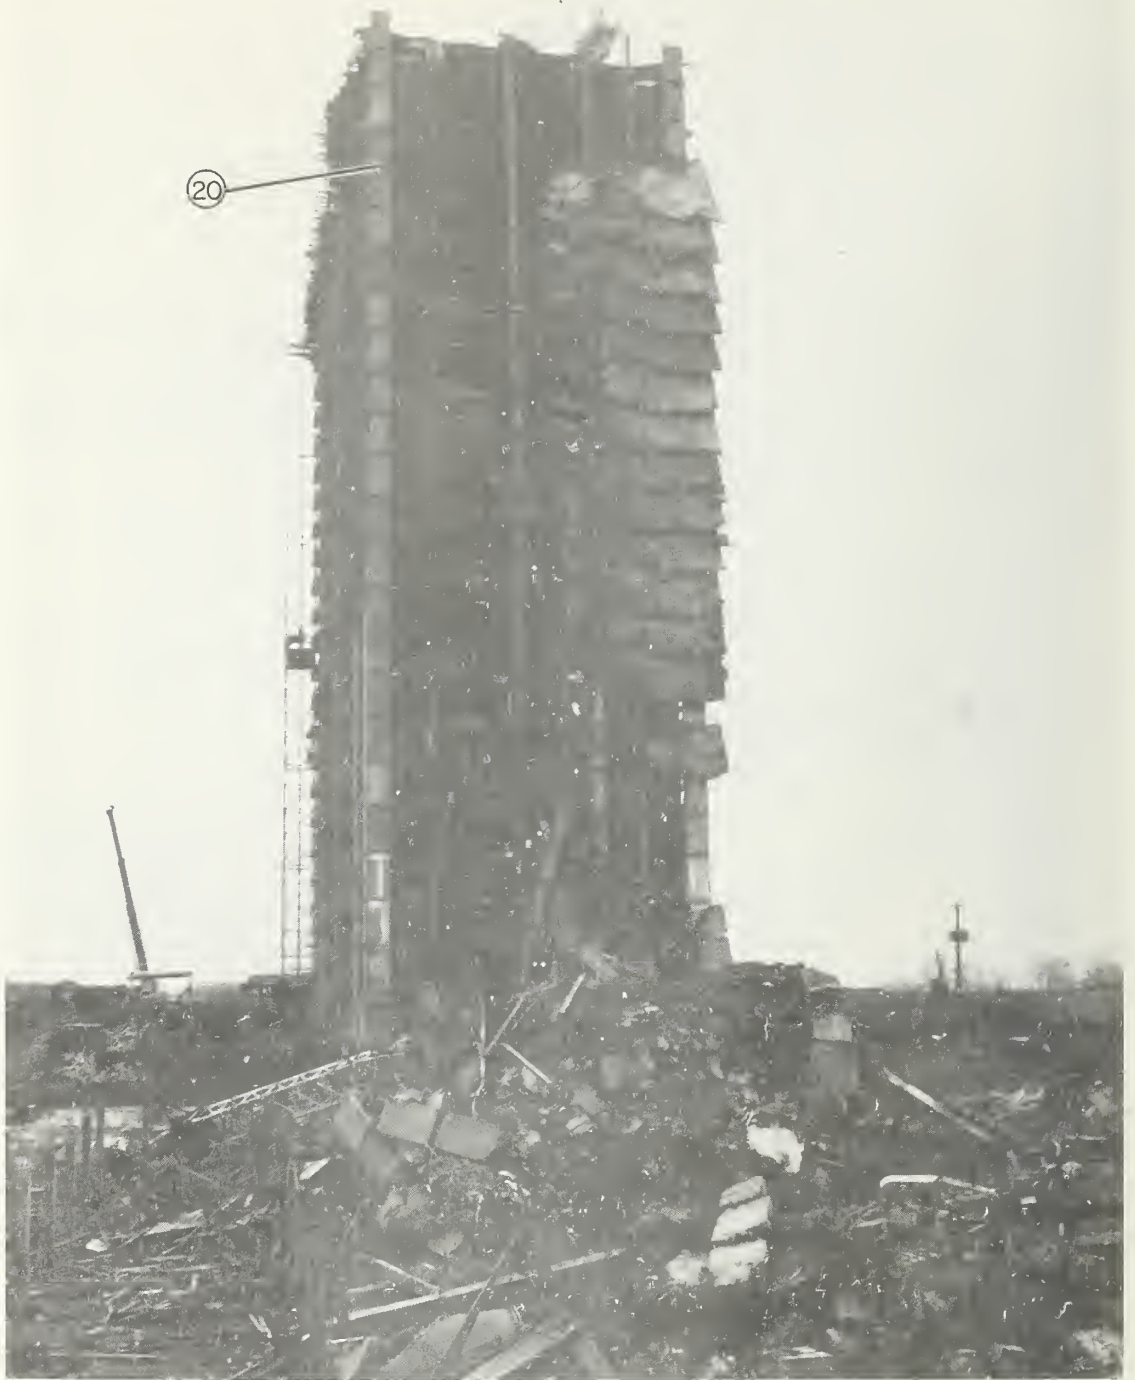
On the night of March 4 the remaining portion of the building to the east of the failure zone was completely demolished, with the result shown in figures 2.13 and 2.14.

Figure 2.13 Appearance of A-4 after the removal of the east end of the building, viewed from the east.

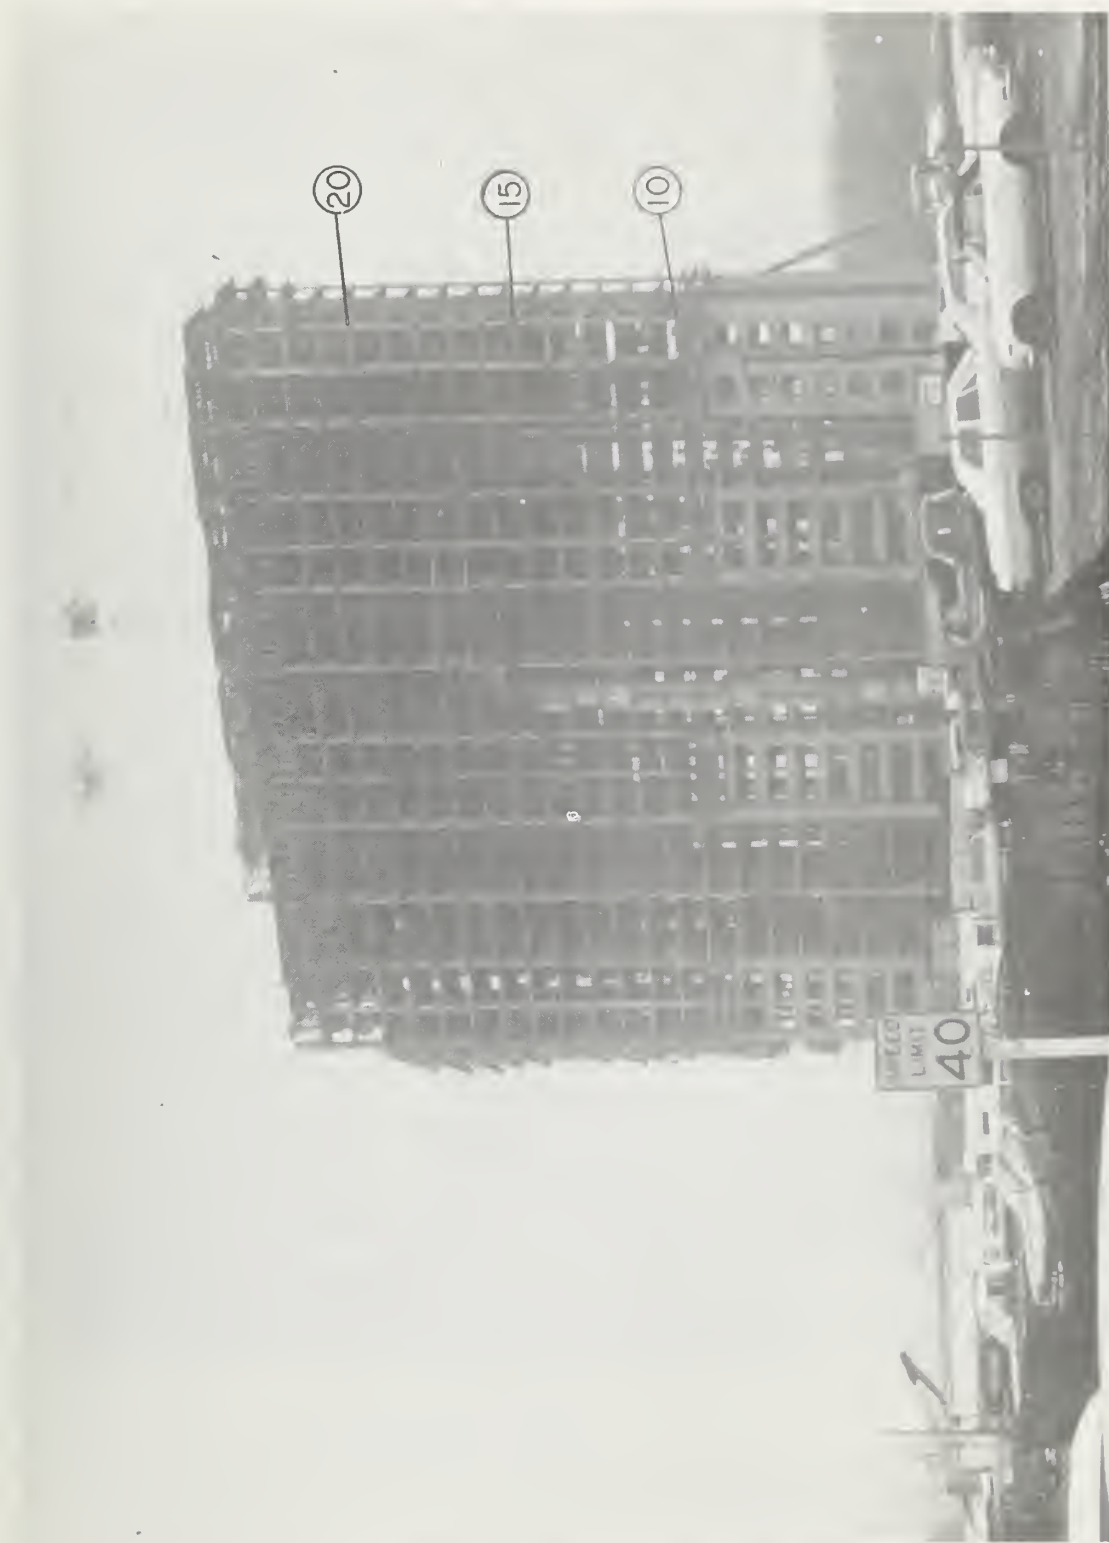
Figure 2.14 North face of building A-4 after partial demolition.

Access was not gained to building A-4 by OSHA personnel until March 5 when the building appeared as in figure 2.14. Most of the photographs used in this discussion of the building interior were taken on or after that date. Between March 2 and March 5, additional shoring was placed in some parts of the building.

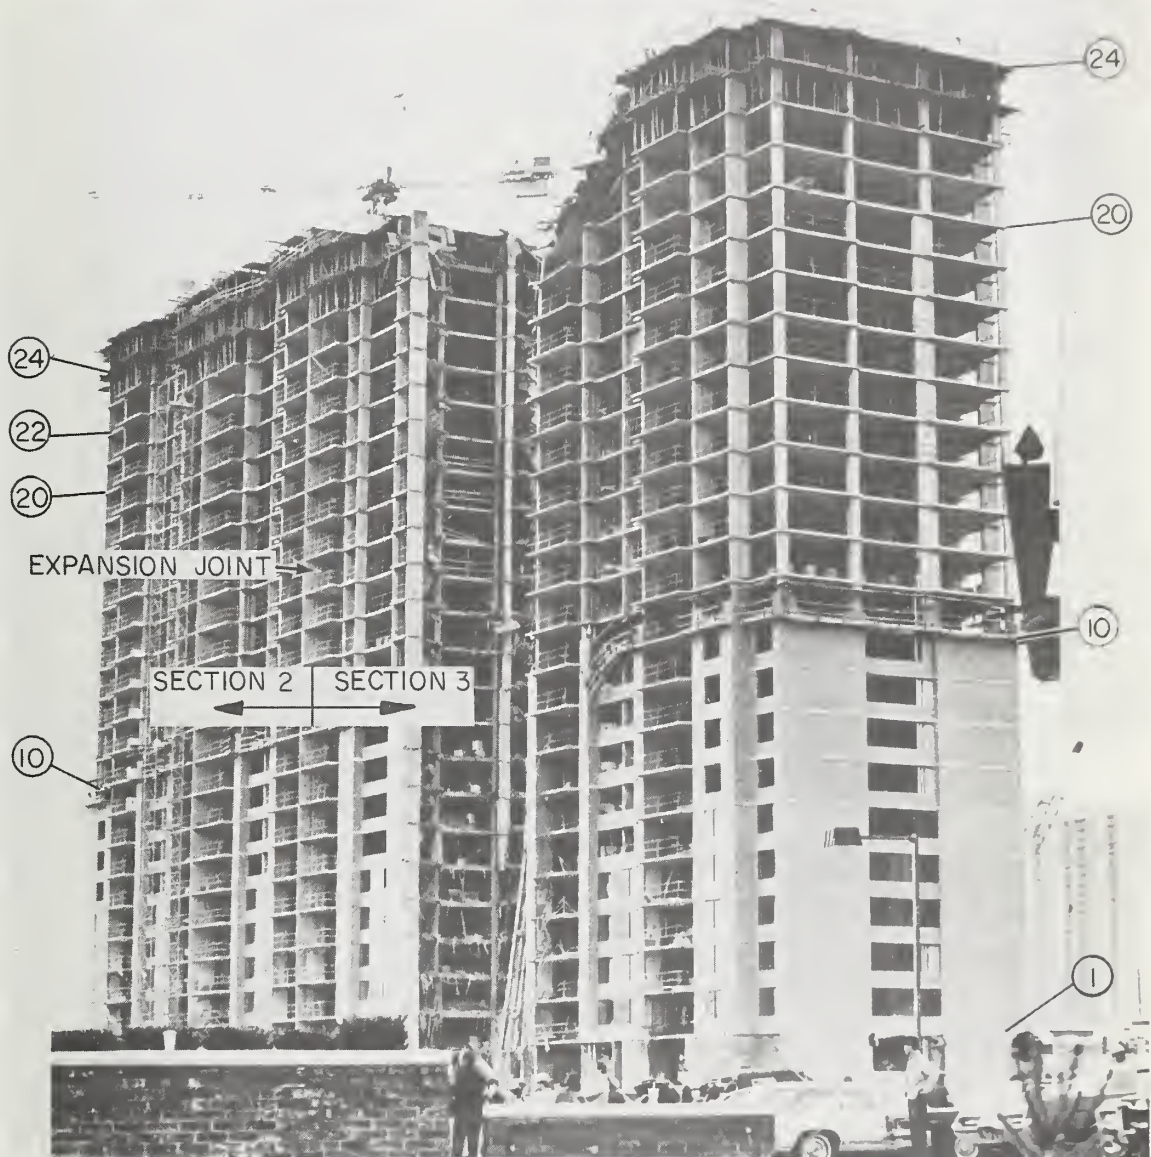
Figure 2.15 shows the locations of the formwork on March 2, shortly after the collapse. Full formwork was in place on the 24th and 23rd stories in sections 1 and 2 (refer to figure 2.1 for location). Some formwork may be seen on the 22nd story in sections 2 and 3. In section 2 this is primarily the area around the material elevator shown toward the western end of the south elevation in figure 2.15. Investigation by OSHA personnel on March 5 indicates that the only formwork not stripped on the 22nd story in section 2 was around that elevator. Employee statements indicate that this area was not stripped in order to prevent lumber from falling on bricklayers working below. Formwork may also be seen in section 3 of the 22nd story in figure 2.15. However, closer examination of the 22nd story in figure 2.10 indicates that formwork was stripped in the center portion of the 22nd story.

Full formwork was also in place under section 4 on the 22nd and 23rd stories. No reshoring can be seen under section 4 below the 22nd floor in figure 2.15 or in figures 2.4, 2.5, and 2.6. Some employee statements indicate, however, that reshoring was present below pour 4 on the 21st story. Other statements contradict this.

Figure 2.15 General appearance of building A-4 as viewed from the southeast.

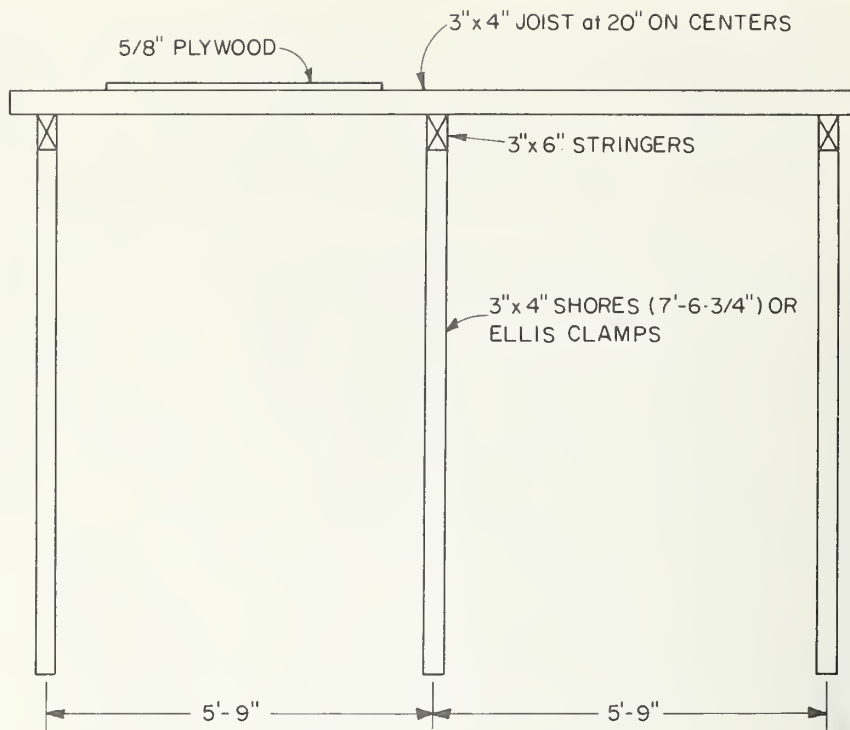
The formwork in figure 2.17 is typical for the floor slabs with design noted by the concrete contractor as being based on the publication, Formwork for Concrete, SP-4 [11]. Formwork sheets submitted to Fairfax County [18] contained no mention of lateral bracing for the form system. However, a limited amount of bracing may be seen in figure 2.16 and some subsequent figures. OSHA regulations (ANSI-A10.9, Sections 6.3.2 and 8.1.5) [2]² require a lateral bracing system capable of resisting a lateral force of at least 2 percent of the dead load of the slab.

Figure 2.17 Formwork for a typical floor.

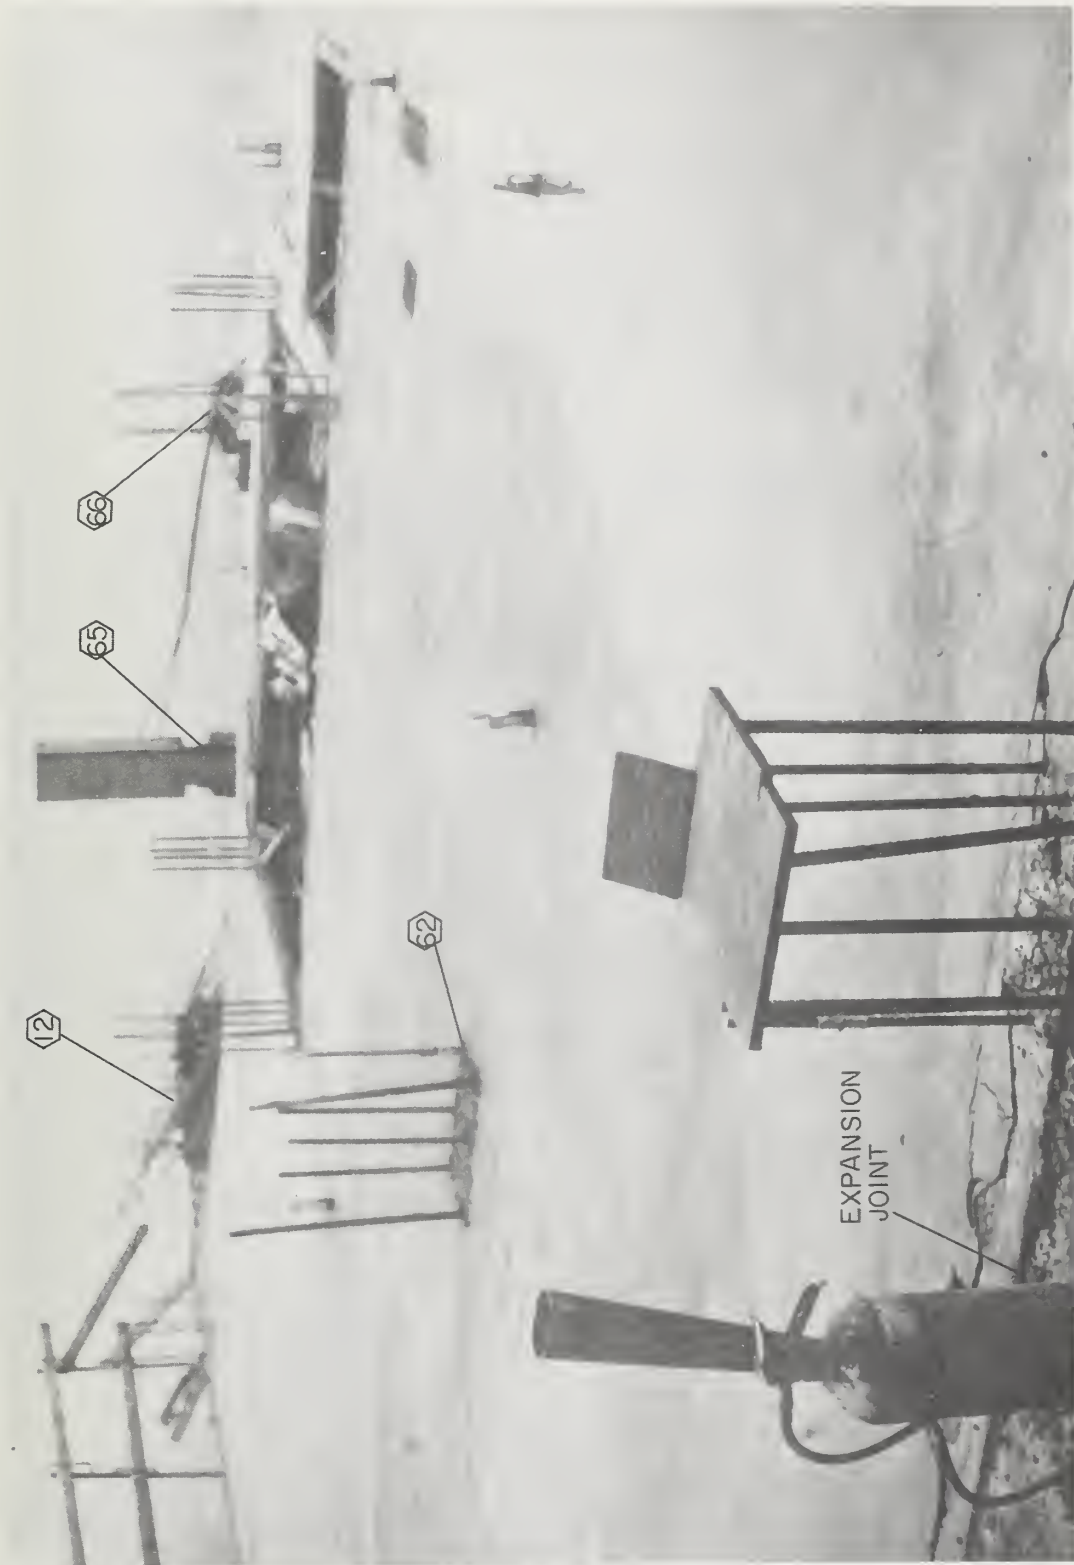
The portion of section 3 of the 24th story slab which remained standing is shown in figure 2.19. This portion of the slab was several hours old at the time of the collapse. Apparently, the only activity on the slab at the time of collapse was work being done by concrete finishers. One concrete finisher working near the stair well (around columns 65 and 66) indicated that a large deflection was seen in the middle of section 3. The statements of numerous employees agree on this point. No statements provided an exact location of the sag. However, the middle of section 3 is about midway between columns 67 and 85 (refer to figure 2.1 for location).

Figure 2.19 Twenty-fourth floor slab in section 3, looking east.

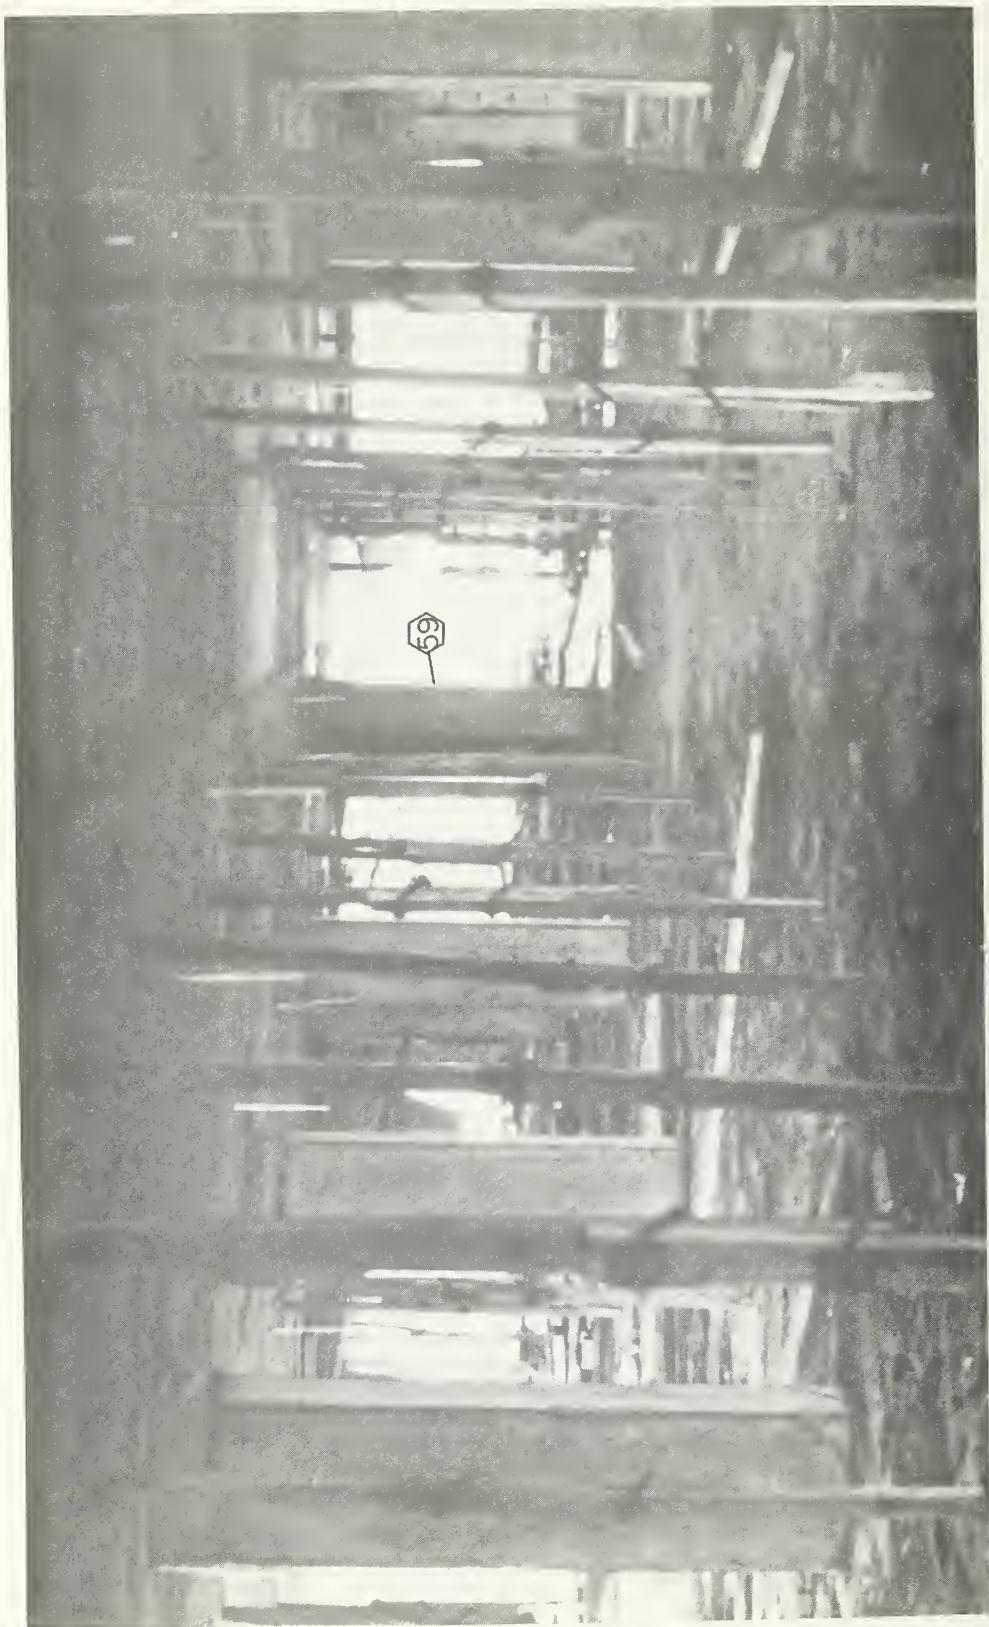
Figure 2.23 Reshoring in section 2 of 22nd story, looking east.

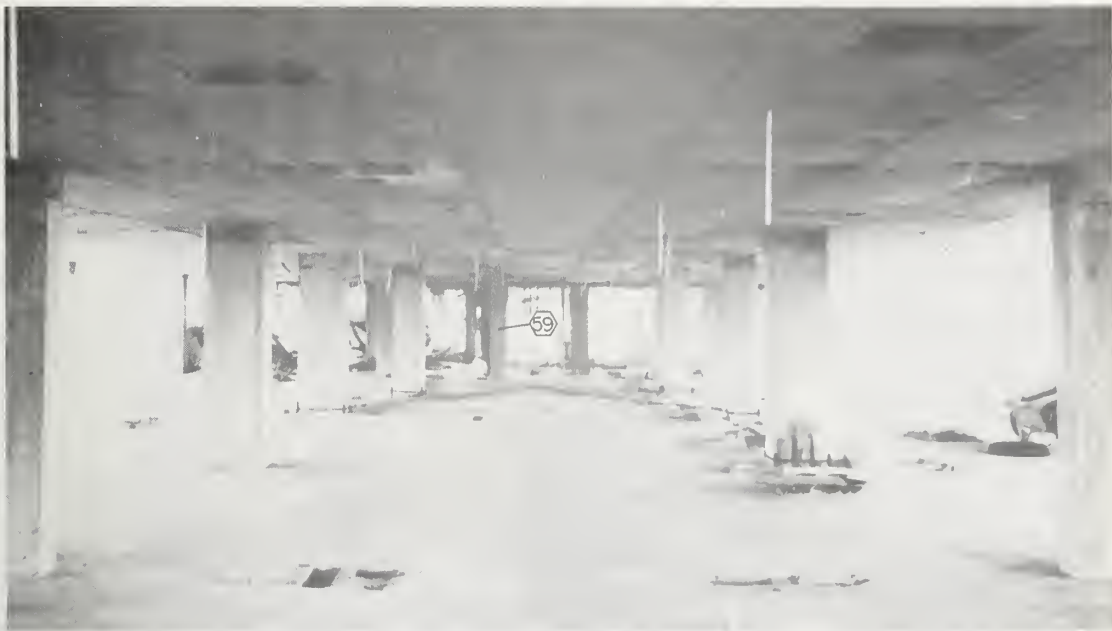
Figure 2.24 Section 2 of 21st story, looking east.

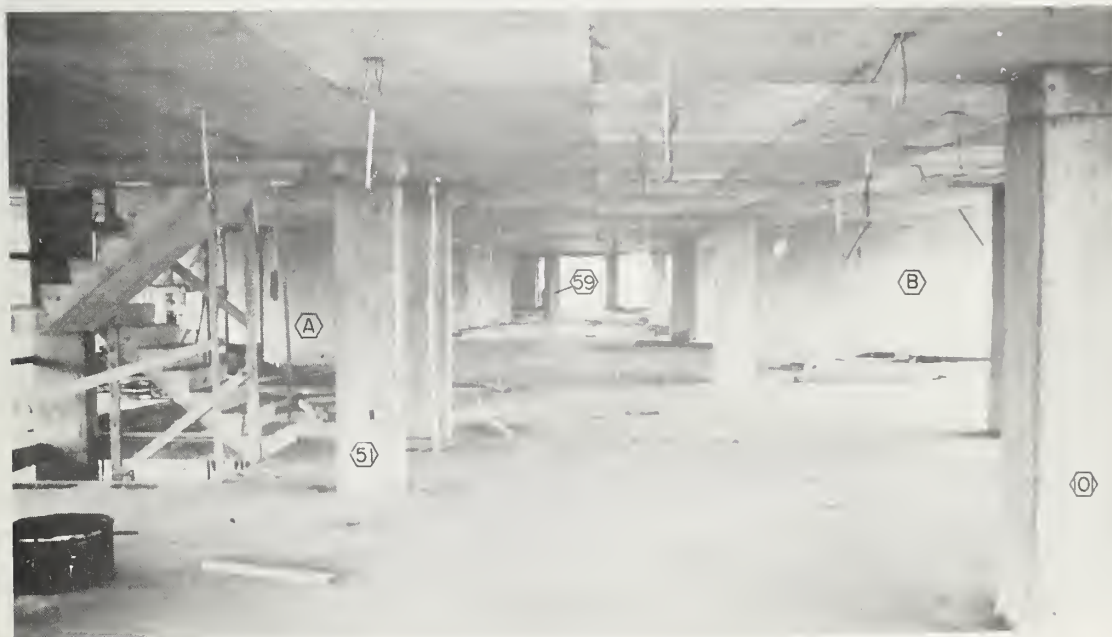
As shown in figure 2.25, the 20th floor was completely bare of reshoring. This was reportedly the case for sections 1 through 4. Note the presence of shear walls A and B. These walls were not present (the design did not require them) above the 20th story. Note also the erection crane which is barely visible to the left of the designation for shear wall A. A view of the failure section at the end of the 20th floor is shown in figure 2.26.

Figure 2.25 Section 1 and 2 of 20th story, looking east.

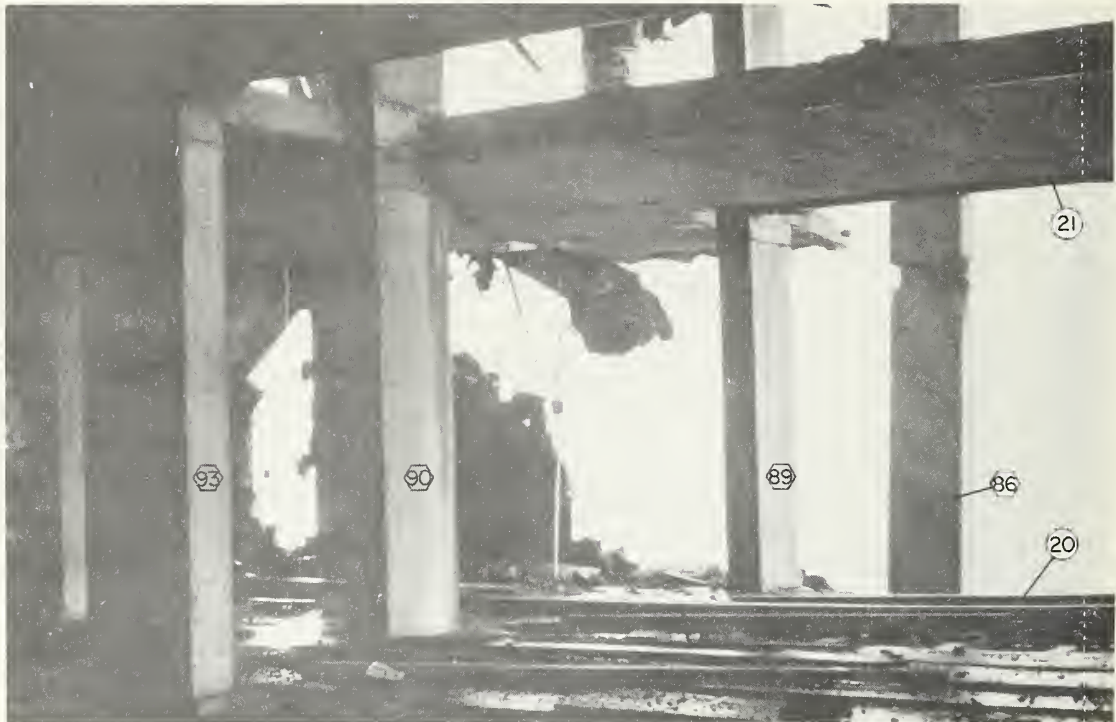
Figure 2.26 Section 3 of 20th story, looking east.

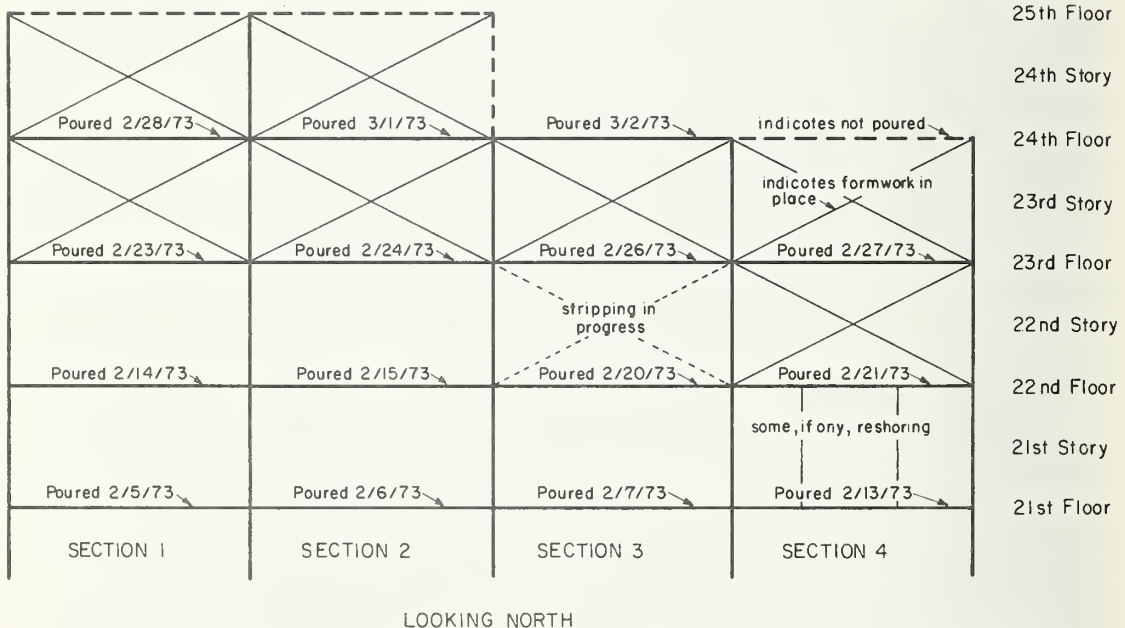
Figure 2.27 Estimated location of forms and reshores at the time of the collapse.

over the following days, it is concluded that all formwork had been removed from sections 1 and 2 of the 22nd story on the day of collapse. The one exception is in the limited area near the materials elevator on the south face of the building. It appears that very little reshoring had been done. Examination of photographs indicates that formwork was in place in section 4 of the 22nd story. Section 3 is discussed later. On the 21st story there was no reshoring in sections 1 and 2. One statement indicates that the reshoring had been removed from section 2 on the day of the accident. Although some statements indicate the presence of reshores in section 4 of the 21st floor, this is not supported by photographic evidence available (figures 2.4, 2.5, 2.6, and 2.15). The photographs at the angle at which they were taken would not show reshoring, if any, located at some distance away from the edge of the slab. It is considered possible that there was some reshoring present although probably a small amount. Section 3 of the 21st story is discussed below.

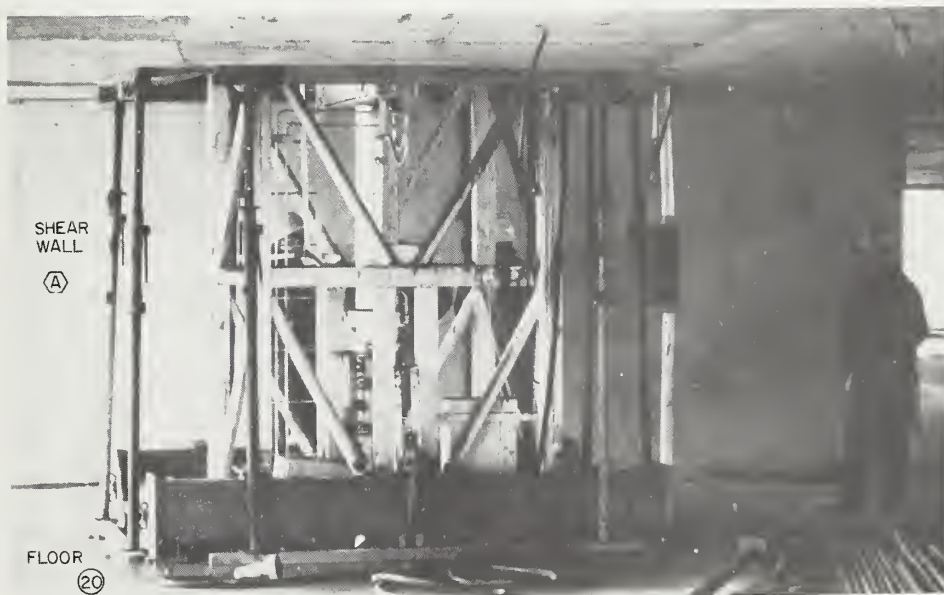
Crane no. 1 was supported by the climbing frame, the lower support, on the 20th floor as shown in figure 2.33. The upper support was provided on the 22nd floor as shown in figure 2.34. This total distance is 18 ft, slightly less than the manufacturer's specified 18 ft 4 in. A typical corner clamp detail on the 22nd floor is shown in figure 2.35. Note the cracked slab where the clamp is attached.

Figure 2.33 Climbing frame for crane no. 1.

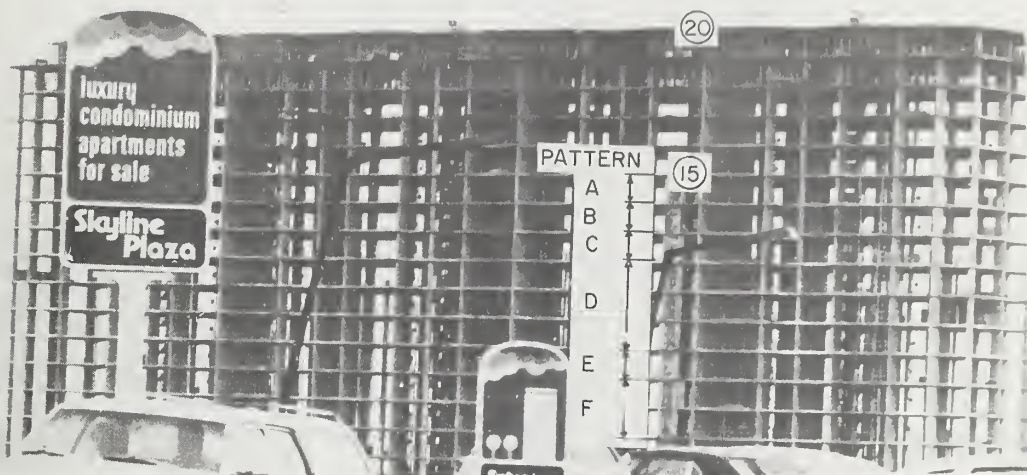
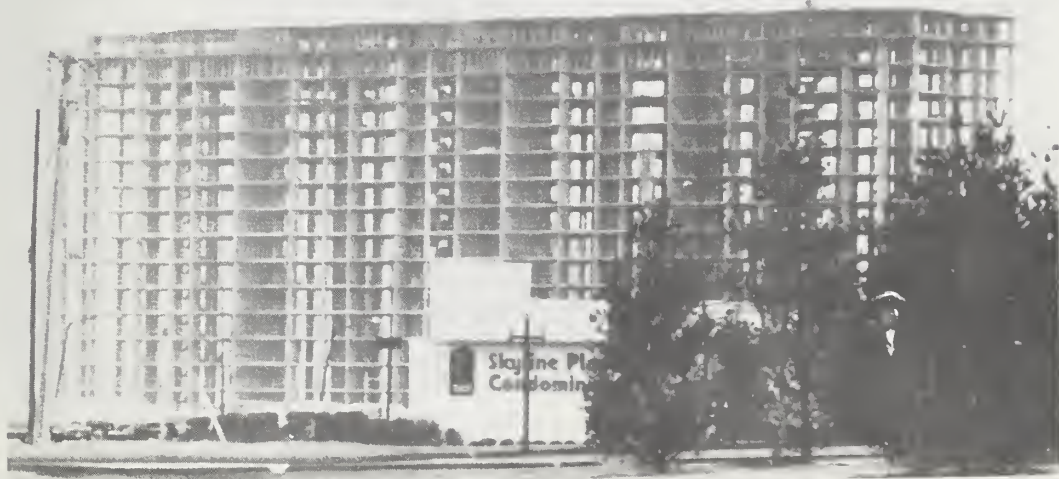
Figure 2.36 contains two construction photos reported as taken around February 10. This date is in error as will be shown. Since the lower floors are not visible it is not possible to tell from figure 2.36 where the cranes are located. Figure 2.37 shows a photograph taken on March 6 that can be used to establish the location of the 15th floor in figure 2.36. A certain pattern of "color" may be seen in the doors and door frames at the elevator landings. A comparison of the patterns between figures 2.36 and 2.37 (taken March 6) establishes the location of the 15th floor in figure 2.36 (It will be seen later that the same door pattern existed in a set of photos taken between figure 2.36 and 2.37).

Figure 2.36 Appearance of construction in early February, looking south.

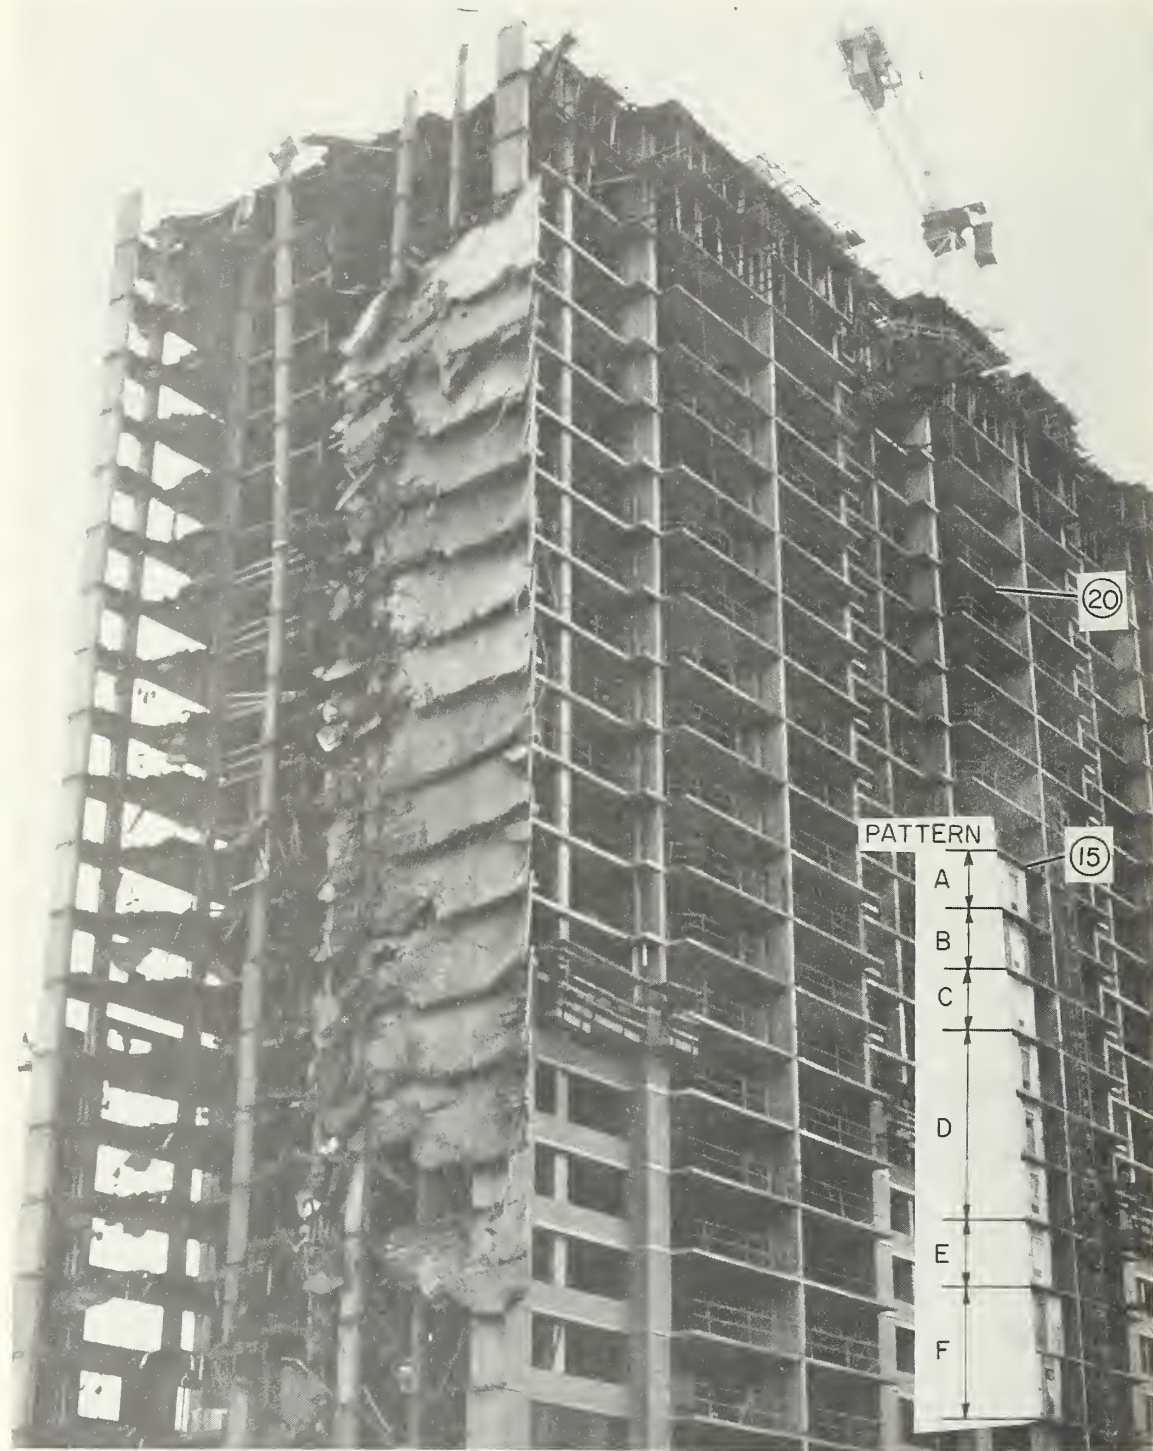
Figure 2.37 Appearance of building A-4 on March 6.

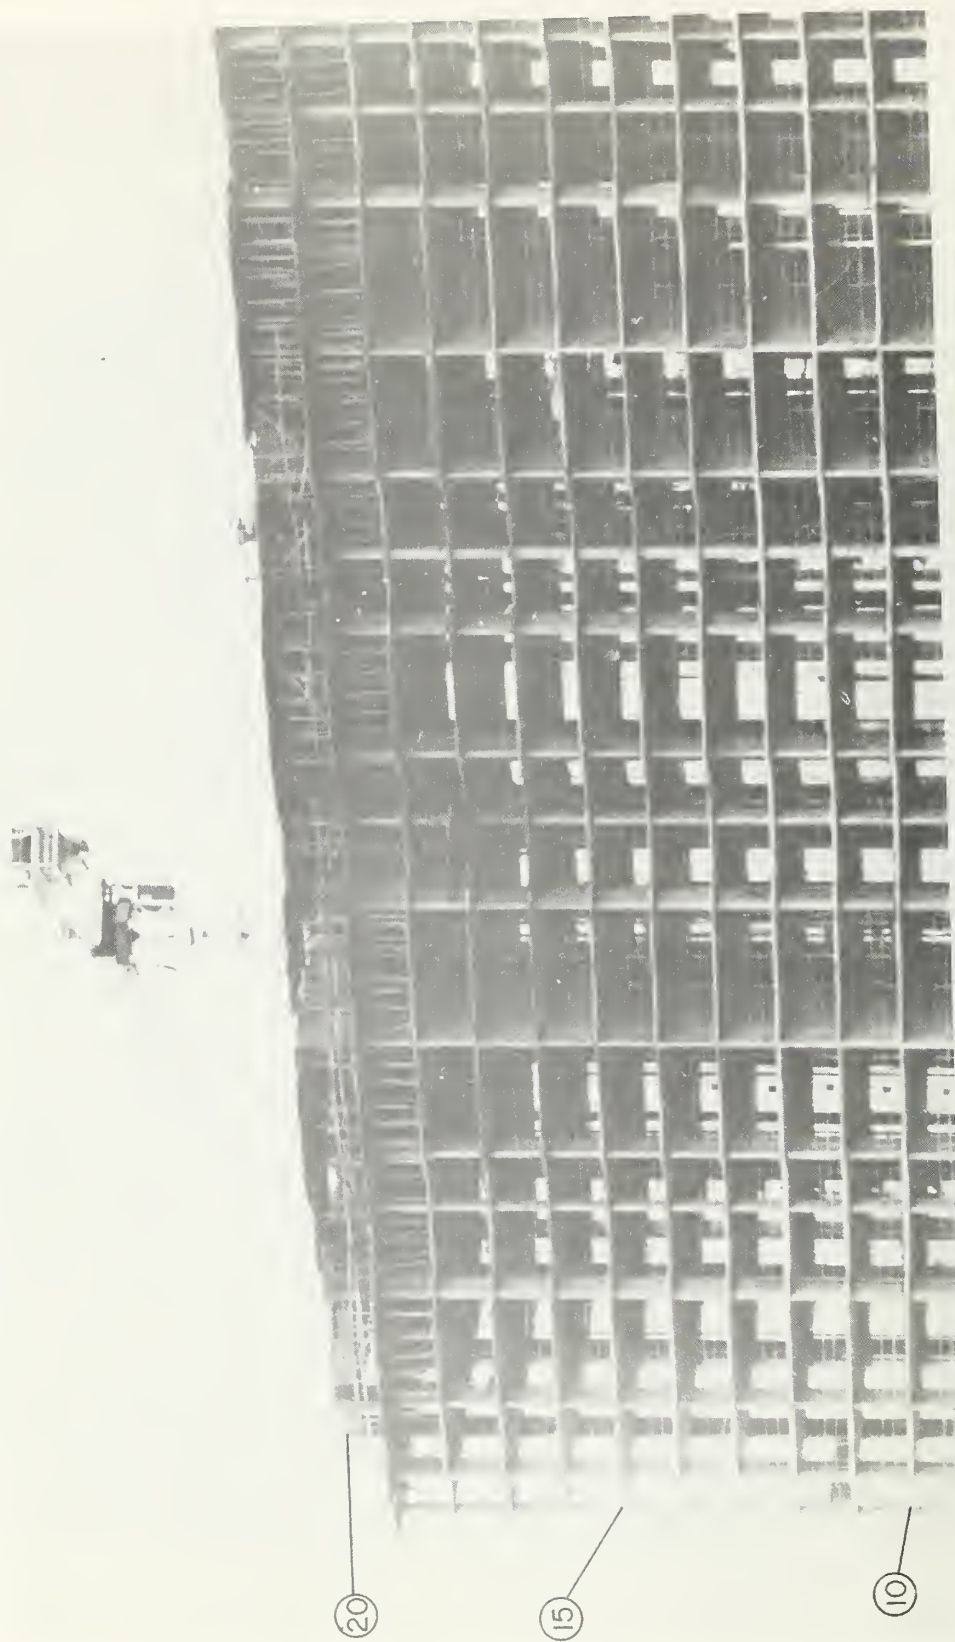
Examination of figure 2.38 establishes the lower crane support on the 10th floor and establishes that the crane, as installed, could operate through a ten-story height of building. It should be noted that the crane had marginal clearance to cast the 20th floor although it appears that it could. The photos were not clear enough to determine shoring conditions under the crane.

Figure 2.38 Closeup view of figure 2.36 showing crane no. 2 base support.

However, based on figures 2.36 and 2.38 the crane no. 2 was attached to the 10th floor between January 26 and February 1. Since this crane was raised only once after February 1, it must have been located on the 14th floor at the time of the collapse.
